M96/97 Engines

Stories about M96 and M97 Carrera engine failures fill the forums but Peter Morgan has been looking at the evidence and talking to the experts. He thinks the problems may not be as widespread as we think...

Story: Peter Morgan Photography: Various

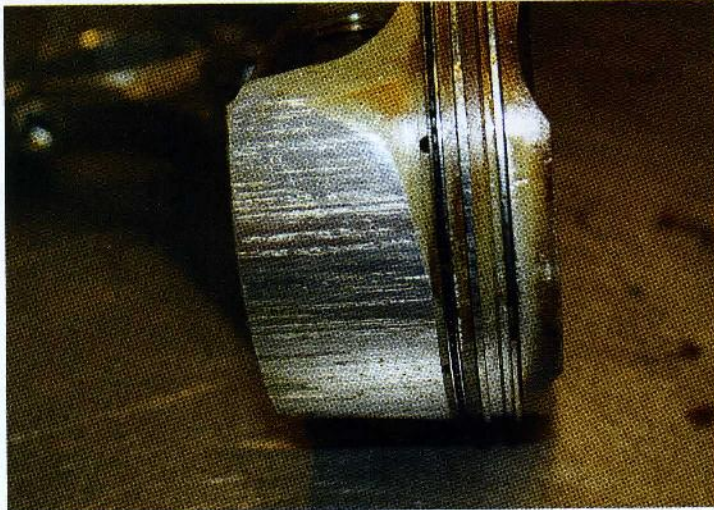
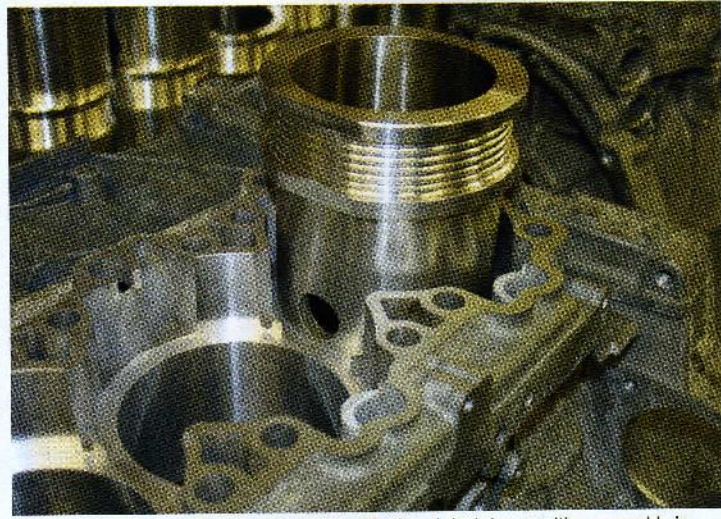
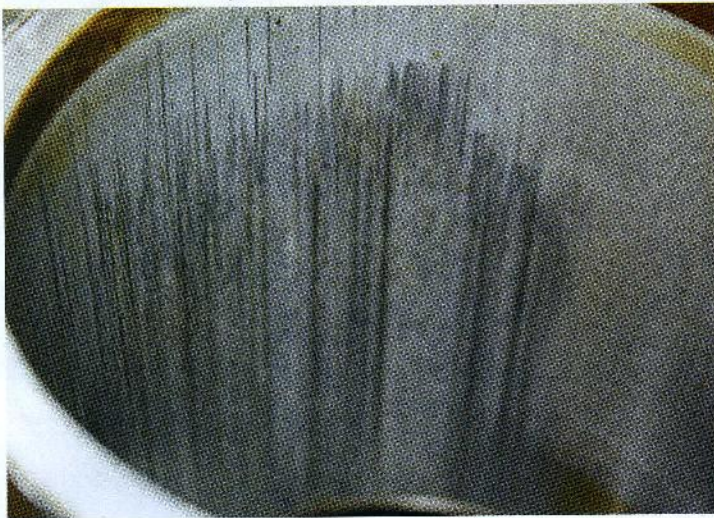
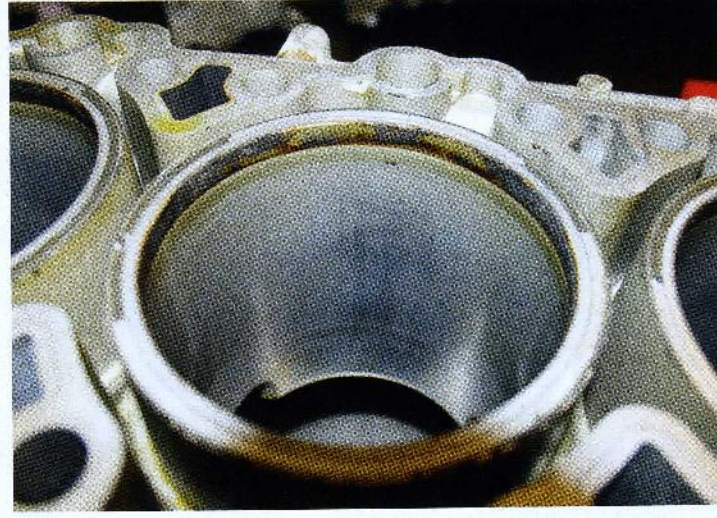
Clockwise from top left: Badly scored piston after prolonged cylinder contact and overheating. Replacement Hartech Nikasil-coated liner with closed deck top awaiting assembly in machined-out crankcase. A polished cylinder liner is acceptable at this stage. Bad cylinder scoring on the thrust face

cases are the Tiptronic between 20-40k miles. They never go through the correct heat cycles, are always used for short journeys at low revs, with the fuel washing the bores. The 3.8s are slightly worse, but we see the 3.6 and sometimes the 3.4 Cayman S engines as well. When these cars come in for their two-year service, the oil is like black treacle and you can smell the fuel in the oil. You can see the sooty exhaust and its usually the number six cylinder that's scored."

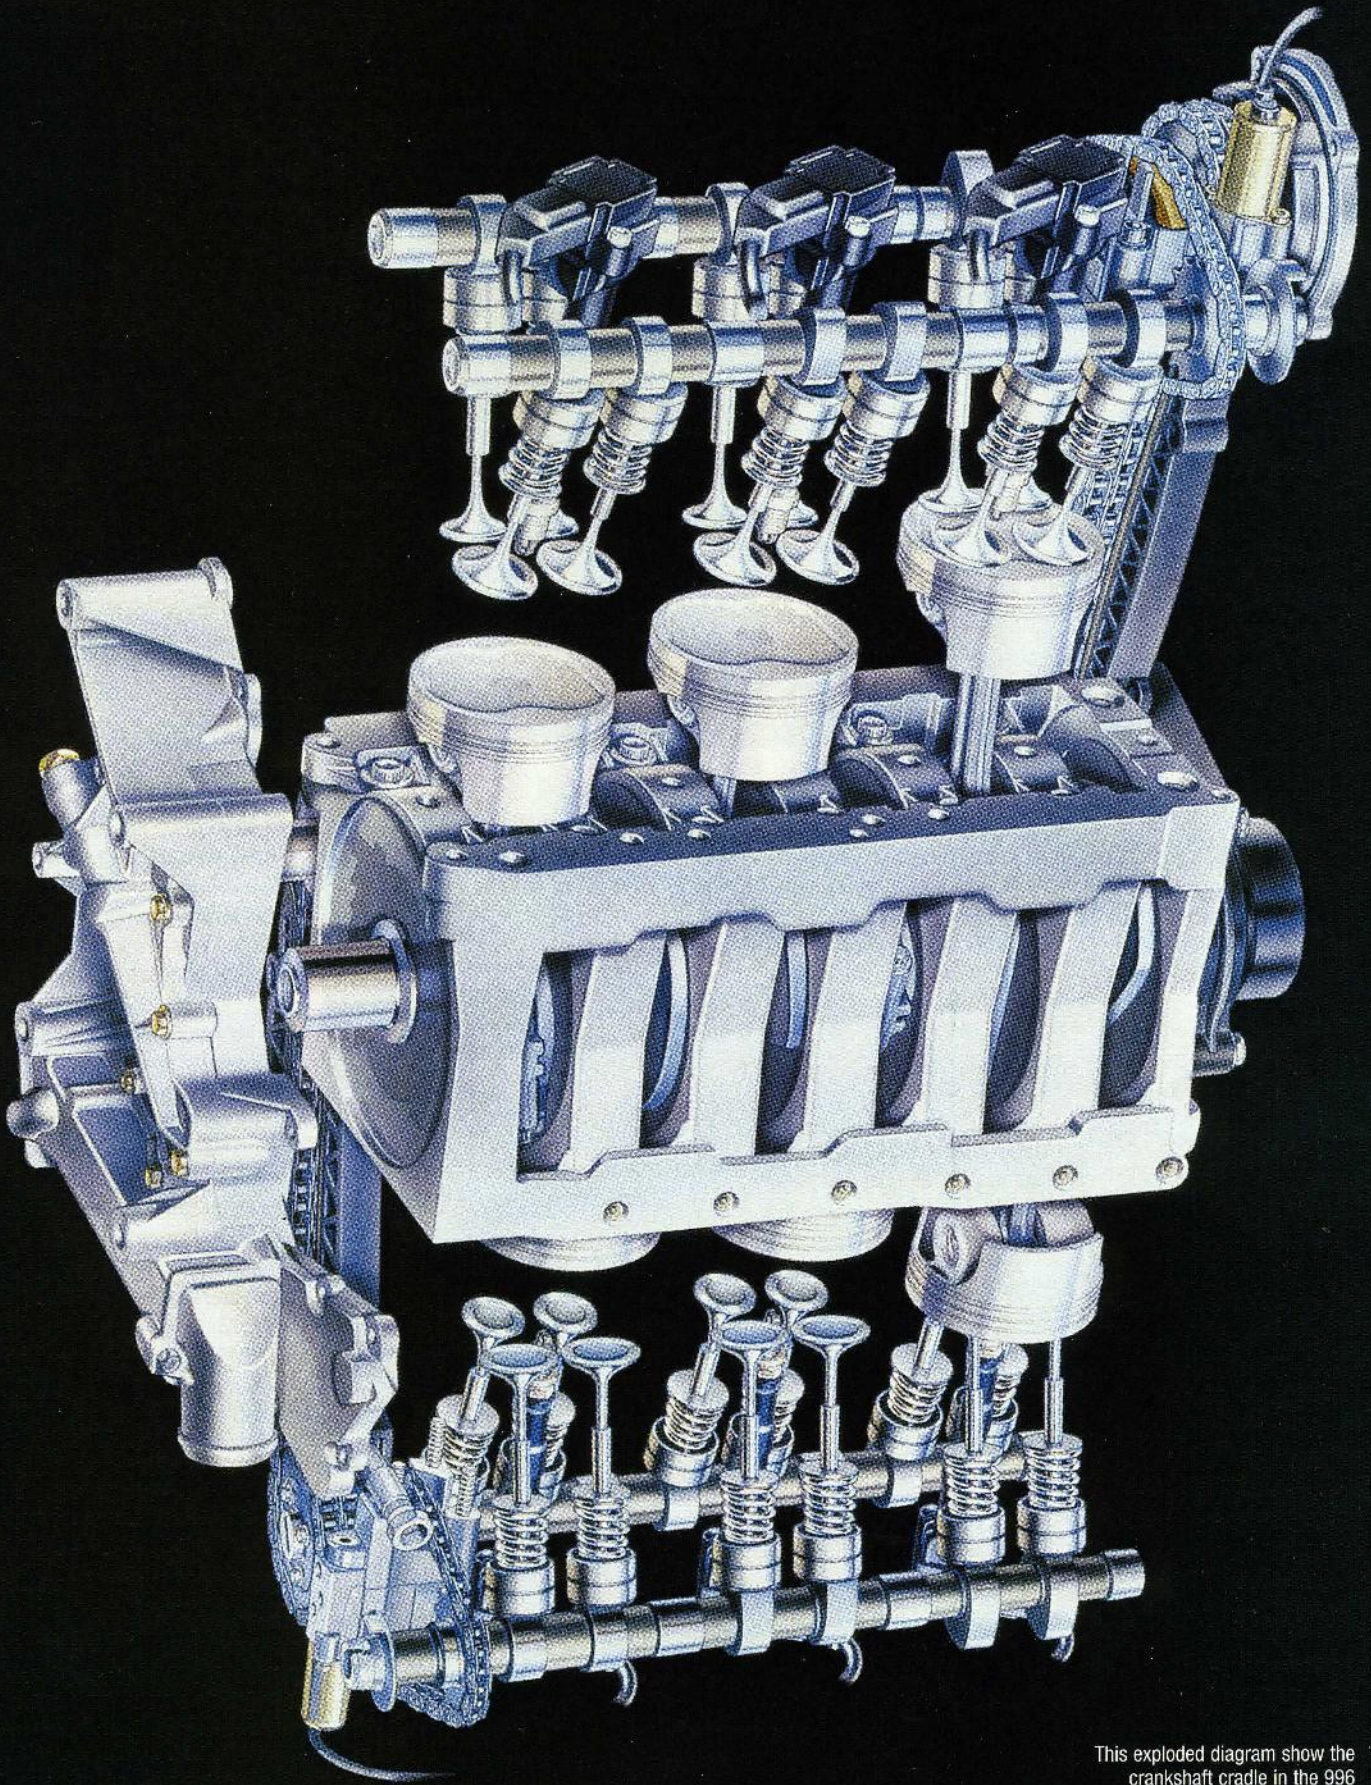
This exploded diagram show the crankshaft cradle in the 996

The cost-optimised design philosophy is nowhere more clear than in the crankcase design. The M96/7 engine crankshaft runs in a fabricated cradle which, in turn, bolts to a weight optimised crankcase. At this point, we can quickly deal with why these engines had oil leakage problems from the rear main crankshaft oil seal (RMS) in their first ten years. There were opportunities for misalignment (tolerance stack ups and flexing have been suggested) between the centre line of the crankshaft and the centre line of the RMS (which was located not in the crank cradle but in the lightweight

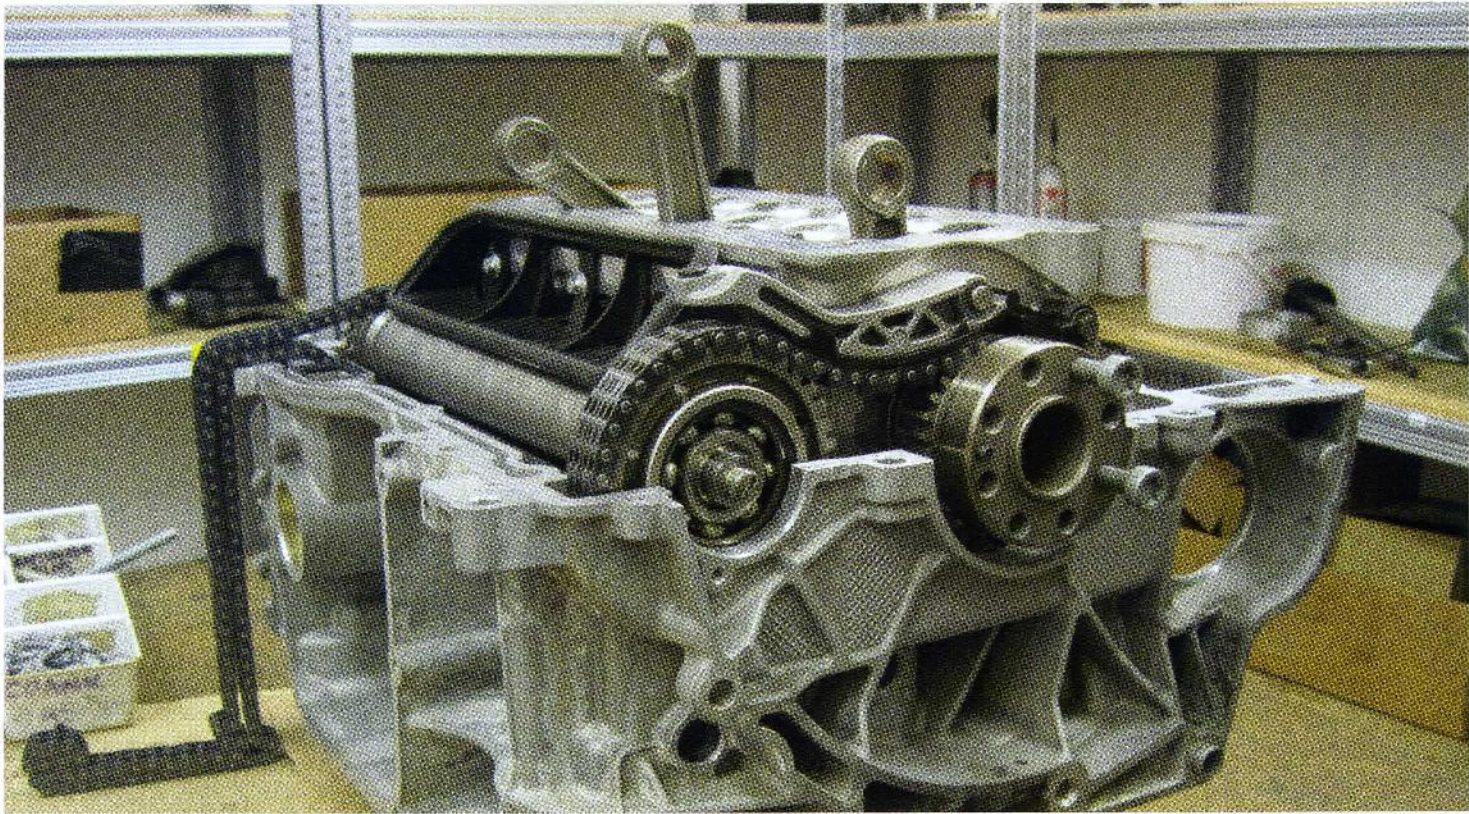
Above: Carrier in casing showing how the RMS seal location is different from the location for the crank carrier, which sits in a machined recess located by two dowels

case halves). Some estimates have put RMS oil leakage to have been as high as 33 per cent of all the 911s and Boxsters delivered in the late '90s and early Noughties.

Leaky main seals made messes of driveways up and down the country, but it was a low level problem as engine damage wasn't likely. After a significant number of RMS revisions the problem was gone by the 2007 models and the new seals can be retrofitted on earlier engines.
