M96/97 Engines

Stories about M96 and M97 Carrera engine failures fill the forums but Peter Morgan has been looking at the evidence and talking to the experts. He thinks the problems may not be as widespread as we think...

Story: Peter Morgan Photography: Various

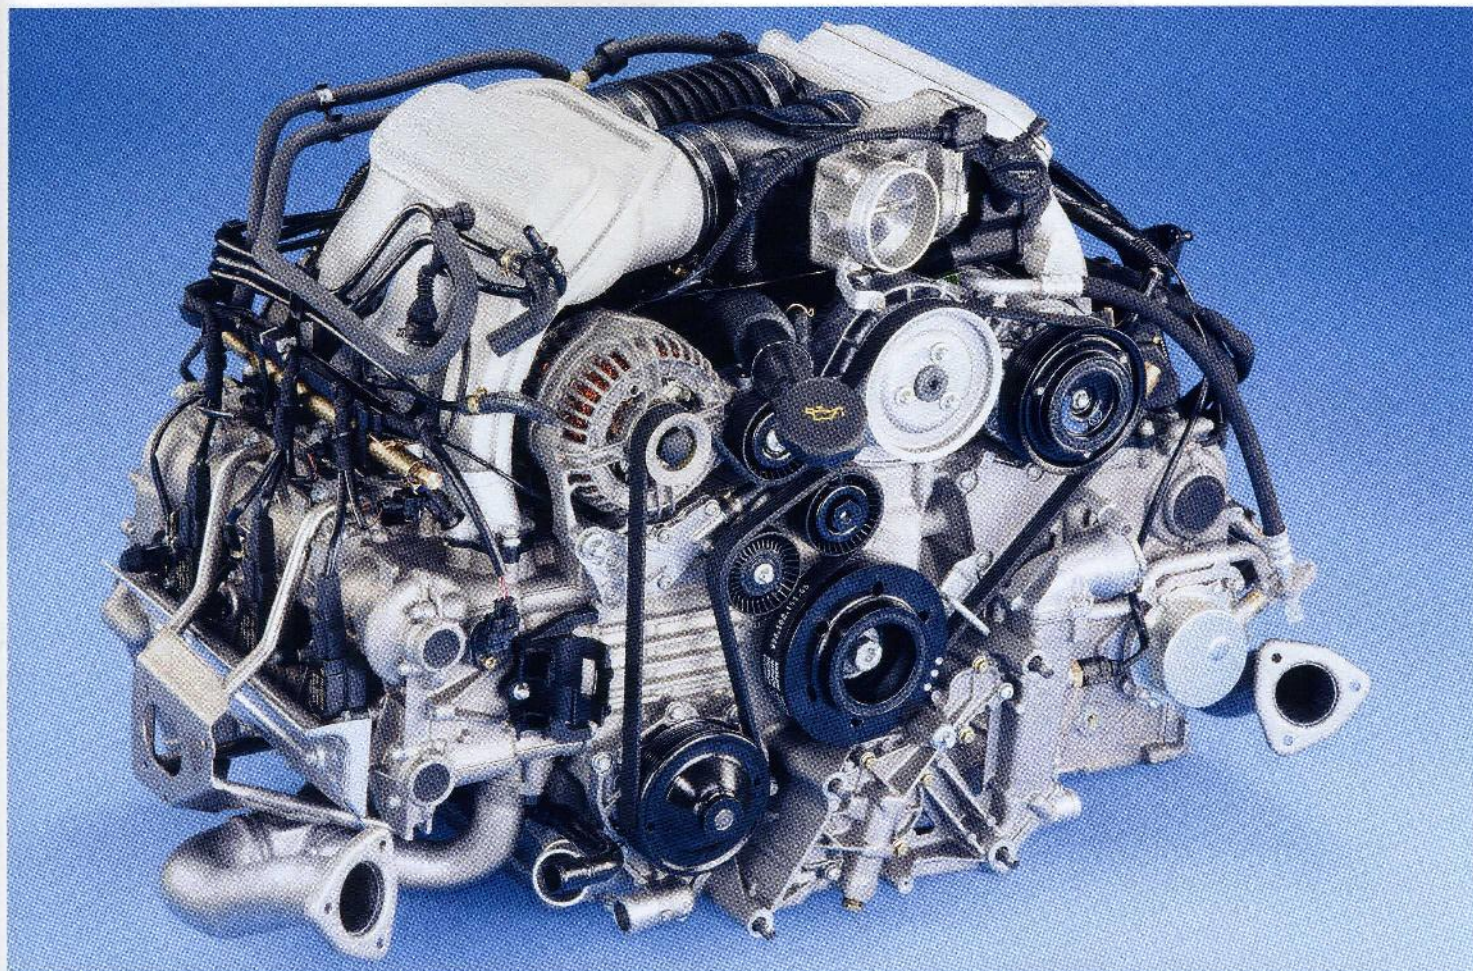
Clockwise from top left: Badly scored piston after prolonged cylinder contact and overheating. Replacement Hartech Nikasil-coated liner with closed deck top awaiting assembly in machined-out crankcase. A polished cylinder liner is acceptable at this stage. Bad cylinder scoring on the thrust face
